This RightShip Insights series provides industry partners with key learnings from industry incidents, identified gaps and leading practices to improve standards and mitigate risk.

This paper discusses issues around **Mooring Operations and Safety Issues**, and:

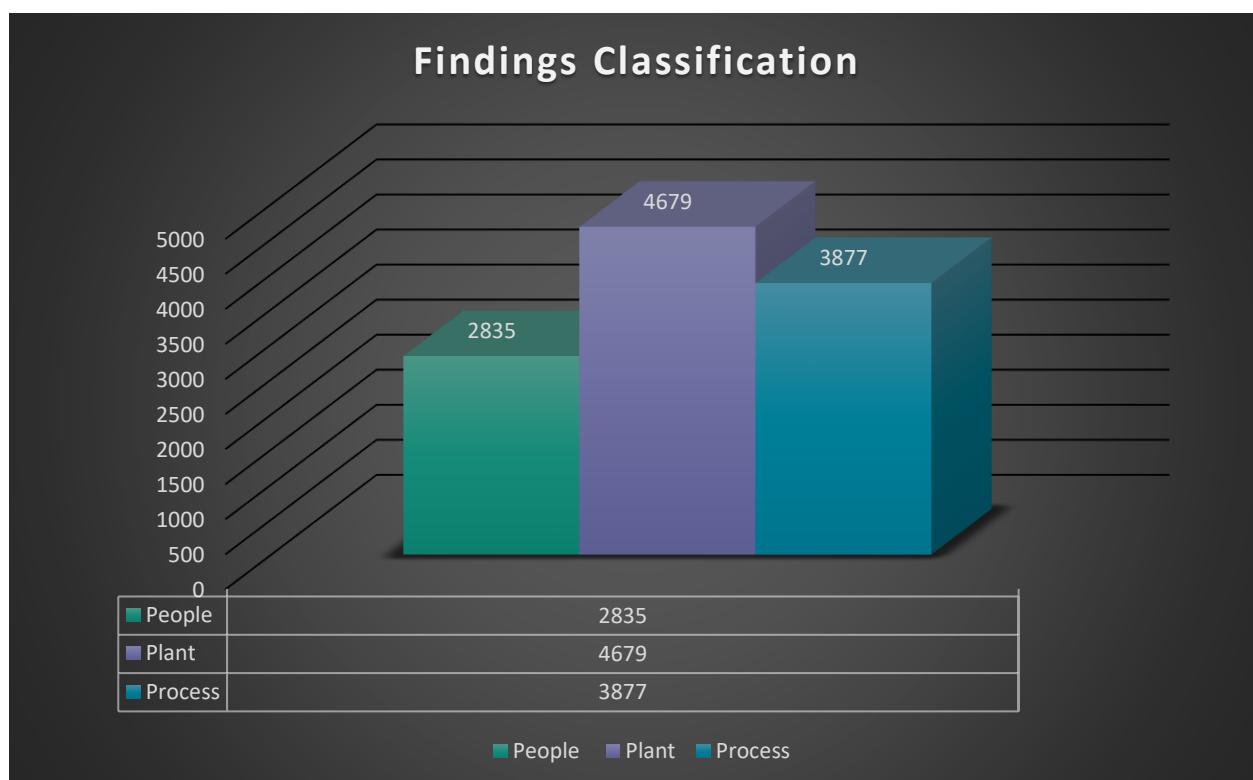
Each finding resulting from a RISQ inspection is attributed to one of the following categories:

- People.
- Plant (equipment), or
- Process.

The chart reveals that the highest number of findings was linked to:

1. Plant, totaling a remarkable 41 % of findings.
2. Following closely was Process, with 34% of findings.
3. People came in third place with 25% of the findings.

The figures above indicate that the human factor is not the sole contributor to these findings; the processes (SMS procedures and guidelines) and the plant (equipment maintenance, OEM maintenance instructions, and the use of OEM spare parts) also significantly contribute to the high number of findings in these areas.

Managers must consider all these aspects when enhancing the SMS guidelines, developing crew training modules for mooring safety, maintaining mooring equipment, and implementing design improvements for new buildings.

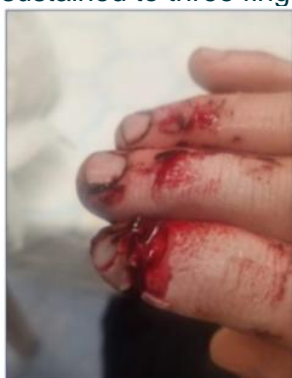
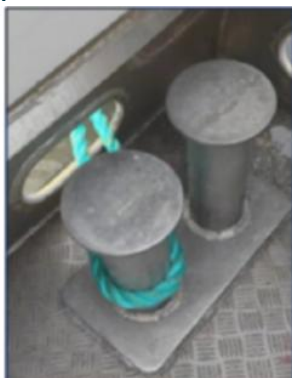
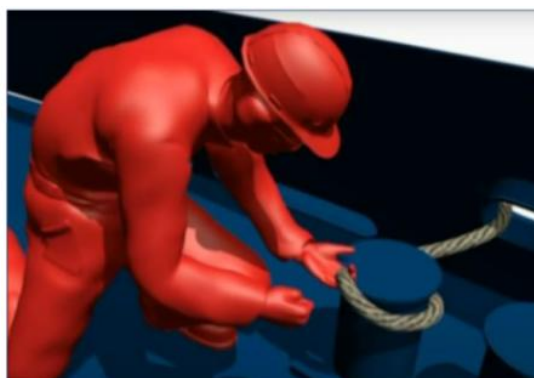
### Case 1:

The incident occurred when a vessel was headed to the pontoon to moor alongside her regular berth. As the vessels' aft port quarter came alongside the pontoon, the deckhand used the boat hook to pick up the 'in-situ' mooring line and began the process of feeding the spliced eye through the fairlead. He then began placing the line over the bitts, this is where the deckhand's fingers on his right hand became trapped, and serious injuries were sustained to three fingers.

- Ensure that sufficient slack is allowed when handling mooring lines.
- Where practicable, the vessel should be stopped before mooring lines are placed over bitts, bollards, or cleats.
- Ensure new personnel (persons who are not yet experienced on a particular vessel) are appropriately familiarized.
- The use of single-ended lines or the use of small rope extensions on the spliced eyes would avoid exposing fingers and hands to risk.
